URALLA HISTORICAL SOCIETY INCORPORATED

PROJECT : Restoration of Chaff Cutting Shed adjacent to McCrossin's Mill, Uralla.

REPORT ON THE PROGRESS OF THE RESTORATION

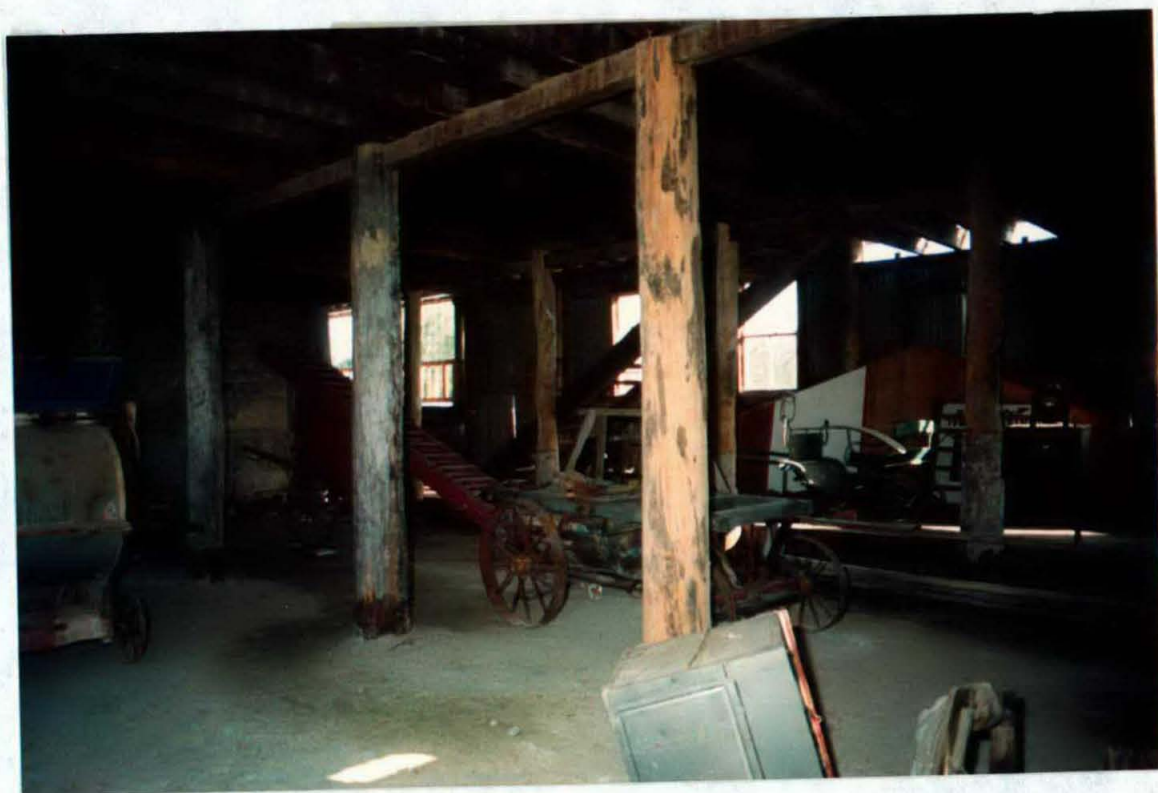
2. One of the main, most expensive and time consuming jobs that needed to be completed was the stabilising of the building and replacement of rotting columns and joists. This photograph shows the new timbers in place. It also shows the new crushed granite flooring and the position of the staircase.

The subsidence of the floor and building was remedied and the structure stabilised.

The rotting columns and joists were removed and replaced with new timber.

The floor was excavated to a solid base and replaced with a bed of compacted crushed granite.

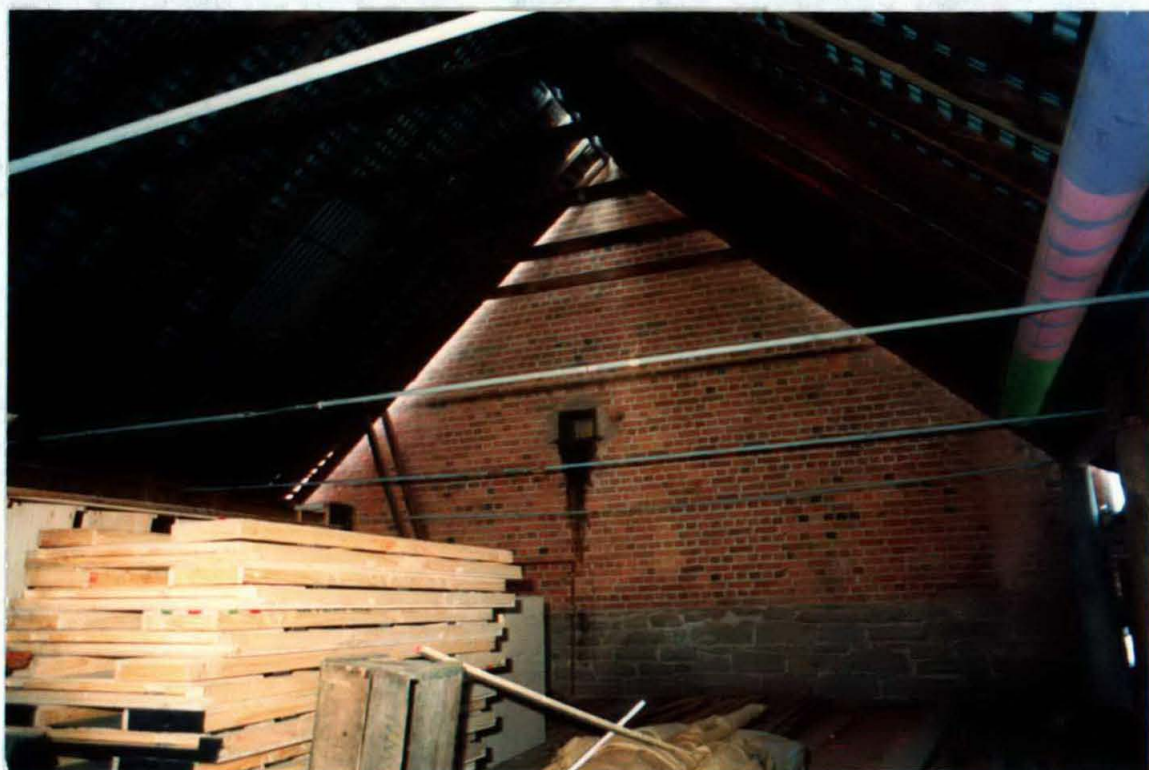
3. Part of the stabilising process was the inclusion of galvanised pipe and turnbuckle braces. These can be seen in this photograph of the mezzanine level. New raft timbers are shown here.

The building was braced and squared with galvanised pipe and turnbuckle fittings.

The rotting rafters were removed and replaced with new timber.

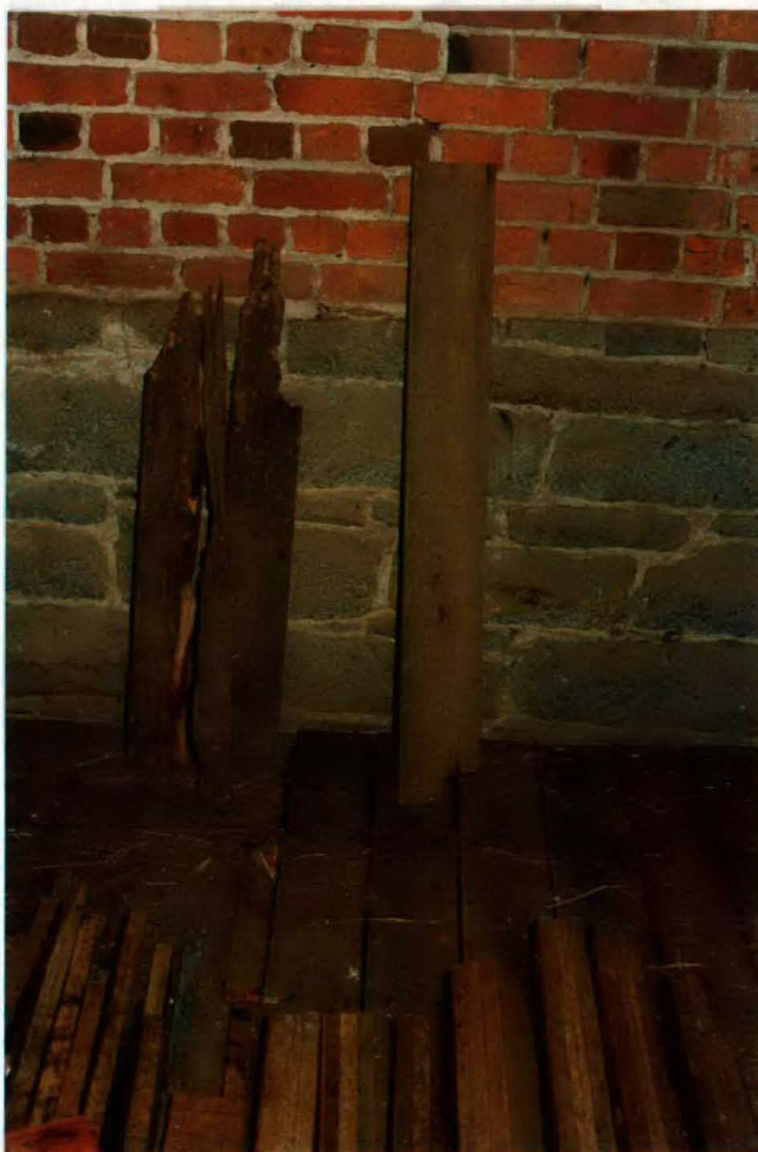
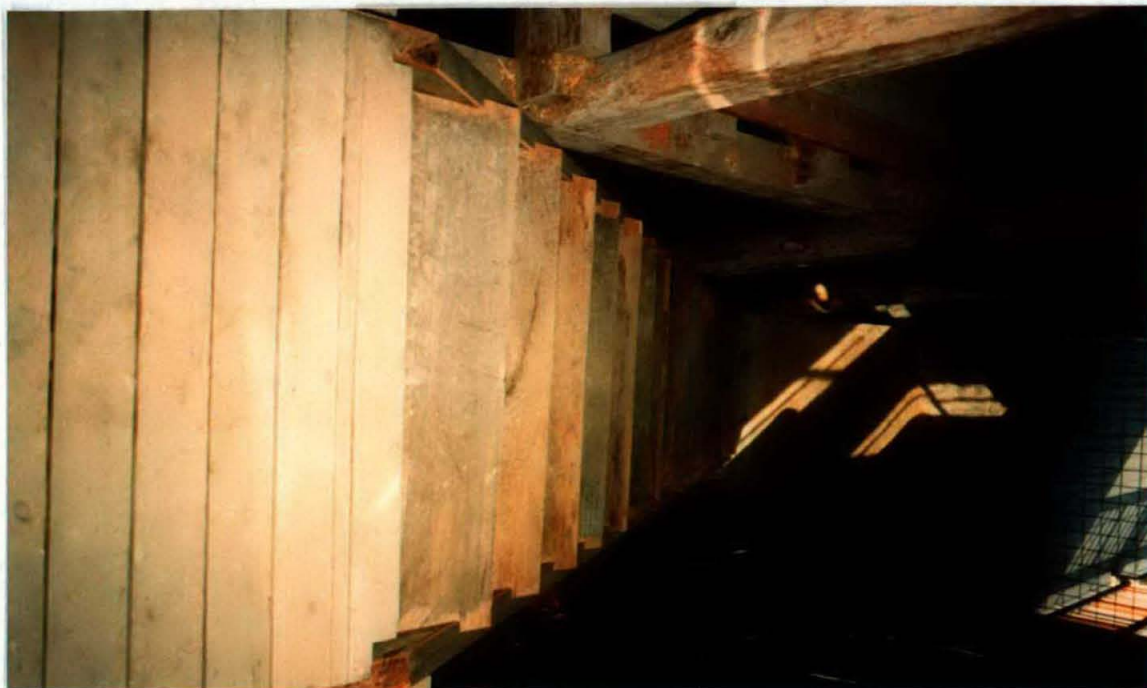
5. The mezzanine access staircase is shown in these two photographs, also note the crushed granite floor.

A Timber staircase was constructed and mounted to the mezzanine floor.

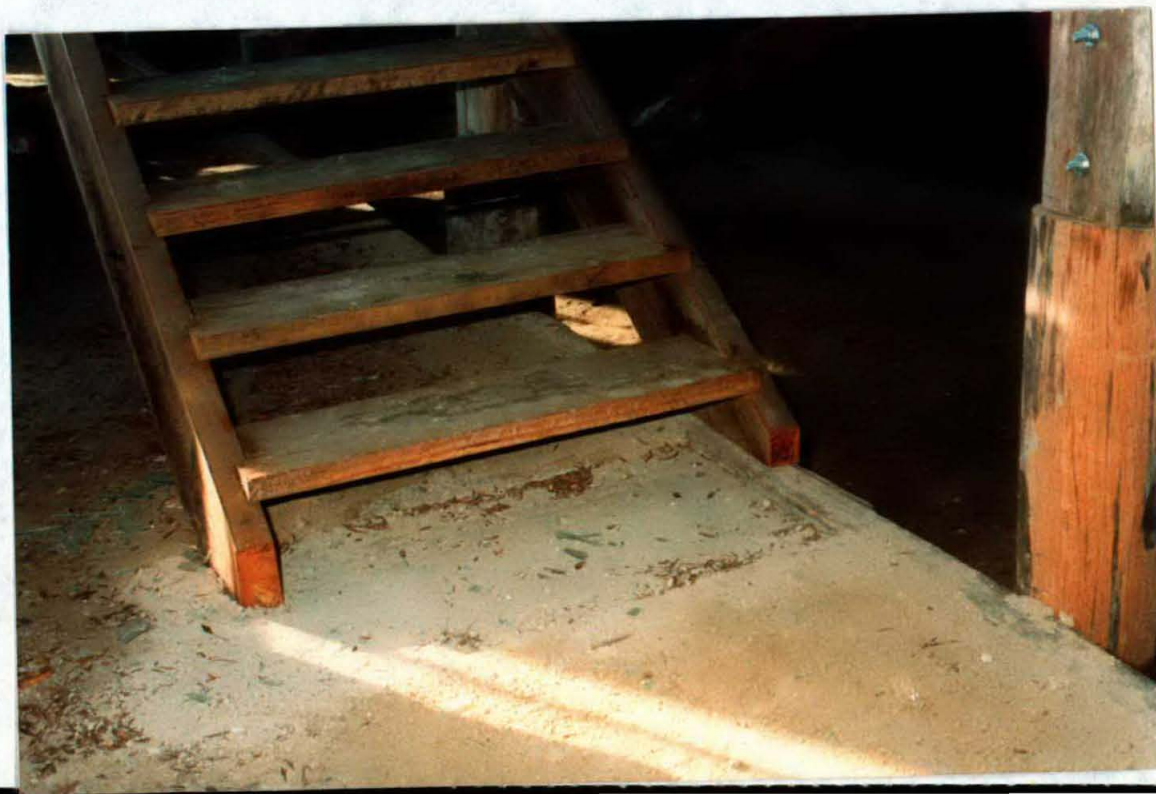
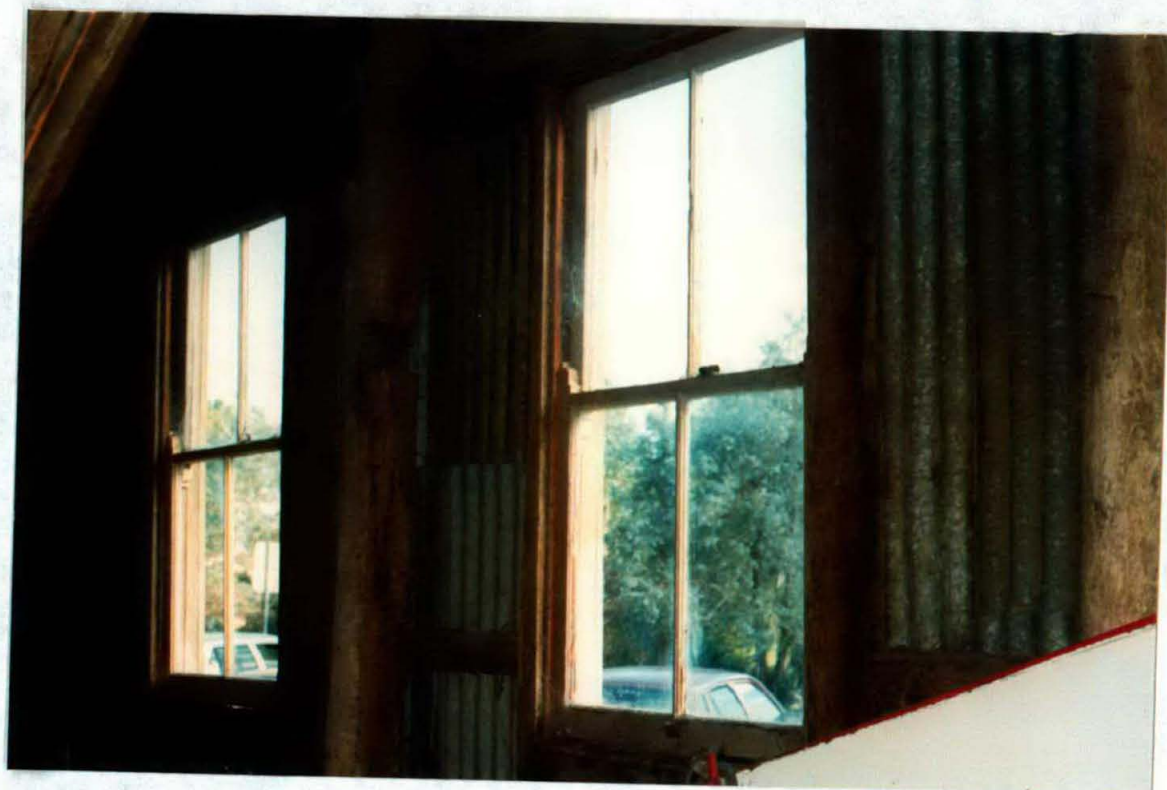
6. Where required the glazing was replaced.

Glazing, where required, has been undertaken.

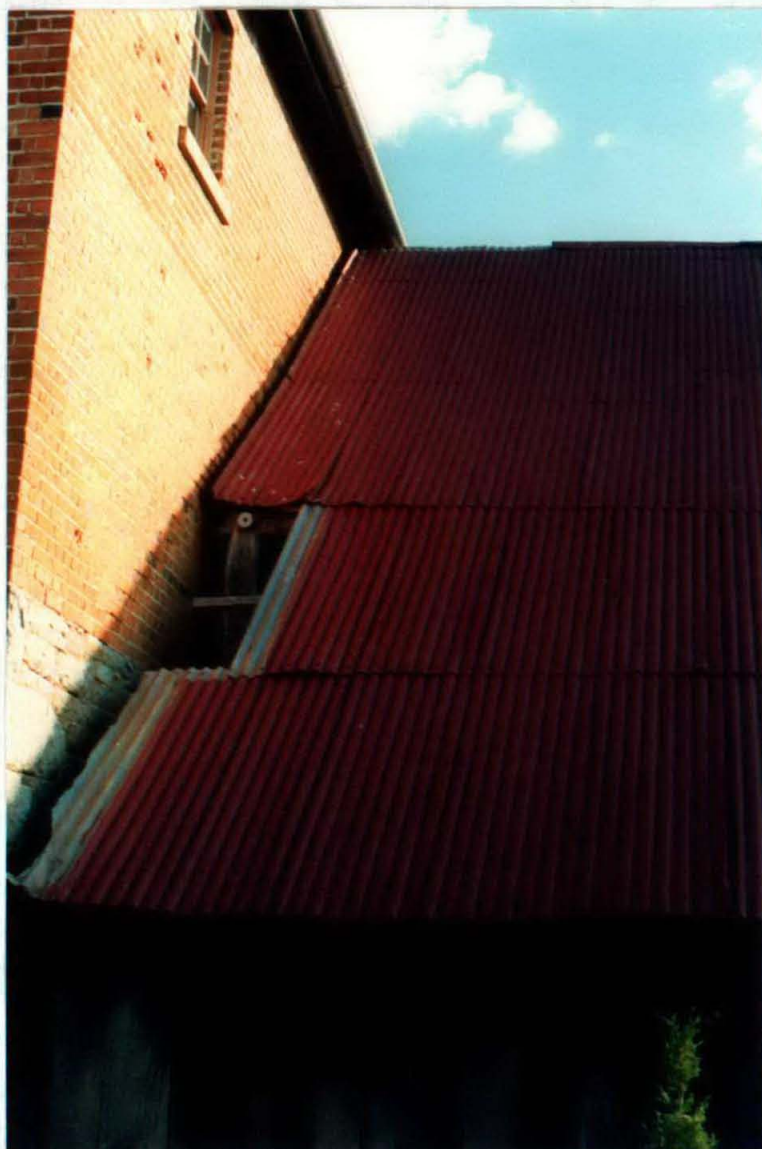
7. To stop further deterioration the roofing iron was painted.

The roofing iron has been painted to prevent further deterioration.

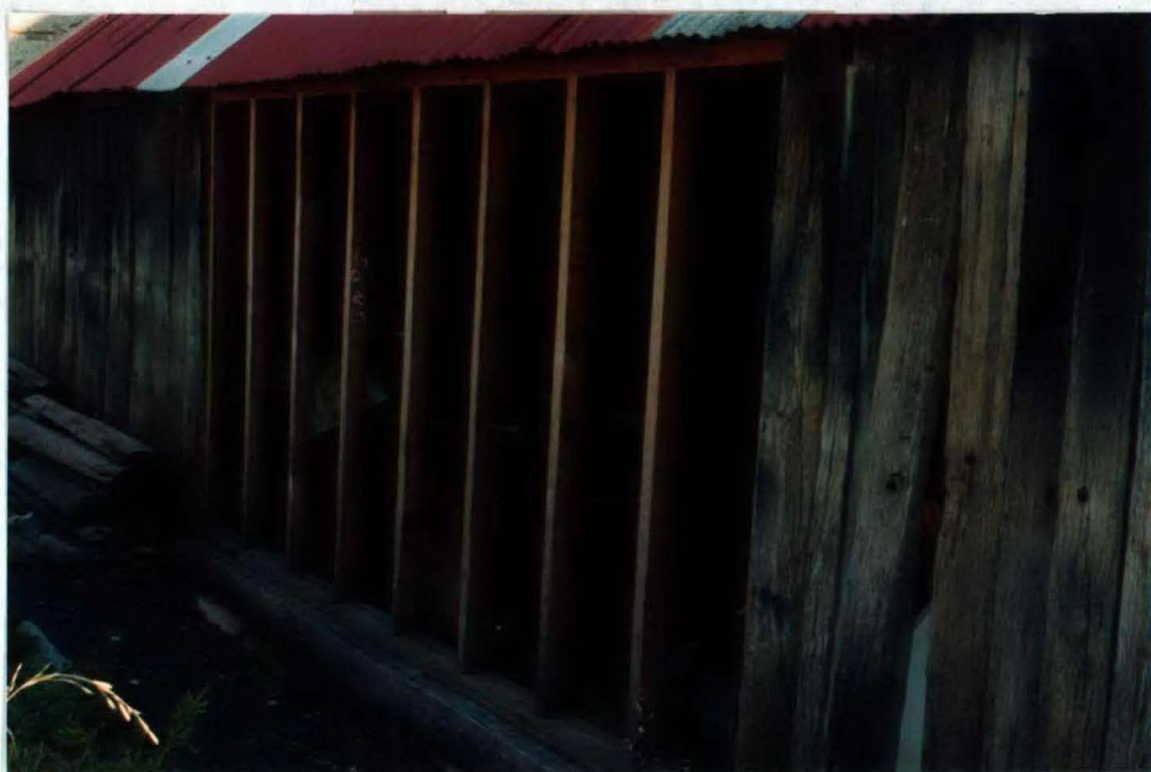
8. To allow light into the display area a section of glass wall is currently under construction at the rear of the Chaff Shed.

Installation of windows in the back wall.
